STATIONWIDE ENVIRONMENTAL BASELINE SURVEY AND RELATED ENVIRONMENTAL FACTORS ONTARIO AIR NATIONAL GUARD STATION CALIFORNIA November 1996

## STATIONWIDE ENVIRONMENTAL BASELINE SURVEY ONTARIO AIR NATIONAL GUARD STATION, CALIFORNIA

**NOVEMBER 26, 1996**

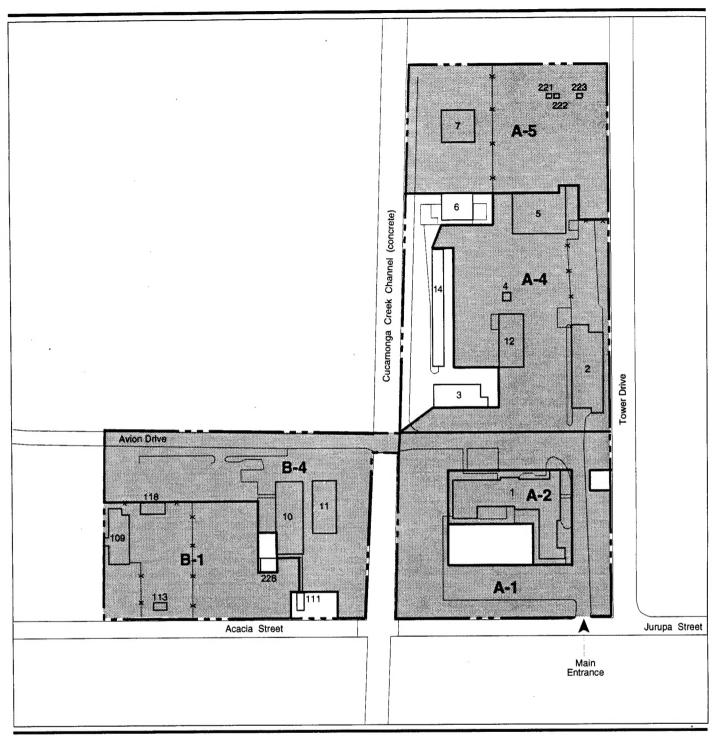
Attached is Table ES-1, which is a listing of all uncontaminated property based on information obtained through a records search, interviews, and visual site inspections at Ontario ANGS. Figure ES-1 depicts their respective locations.

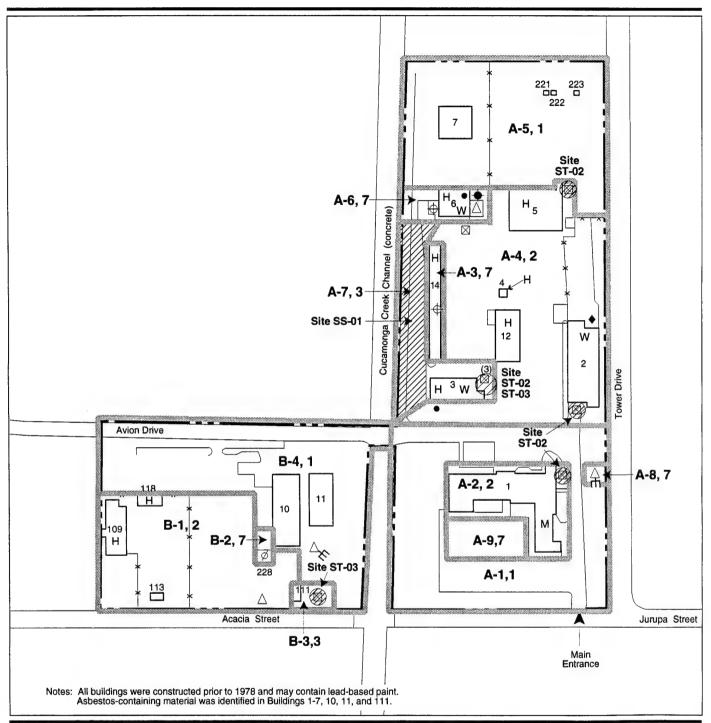
As described above, property on Ontario ANGS was classified into one of the eight categories based on the findings of this EBS (see Figure 5-2). Specific property categorization by study area is described in Table 5-1 and shown on Figure 5-1. A summary of uncontaminated property by study area is presented in Table 5-2 and illustrated in Figure 5-3. A listing of facilities by study area and property category is presented in Table 5-3.

Category 1 properties generally occur in the vehicle parking area for Building 1, the northern portion of the station where munitions storage activities once occurred, and around the administration and dining hall west of Cucamonga Creek. Category 2 properties occur throughout the central portion of the station including Buildings 1, 2, 4, 5, and 12; and most of the area west of Cucamonga Creek. Category 3 property is associated with IRP Sites SS-01 and ST-03. Portions of the storm drain system are also considered Category 3 as a result of past disposal activities. No Category 4, 5, or 6 properties were identified. Category 7 properties include Buildings 6 and 14 where subsurface soil conditions at OWSs are unknown. A grease trap (Facility 228) located adjacent to Building 10 is also considered Category 7 due to unknown subsurface soil conditions. The septic tanks and leach fields associated with Buildings 2 and 6 may have received hazardous substances and are considered Category 7. An area located south of Building 1 may have been utilized as a burn pit in the mid-1940s and is considered Category 7. IRP Site ST-02 is considered Category P<sub>R</sub> as a result of past releases from fuel oil USTs. IRP Site ST-02 is considered Category  $P_R$  as a result of past releases from fuel oil USTs, but is not shown on the figure because other factors contribute to the property, which outweighs Category  $P_R$ .

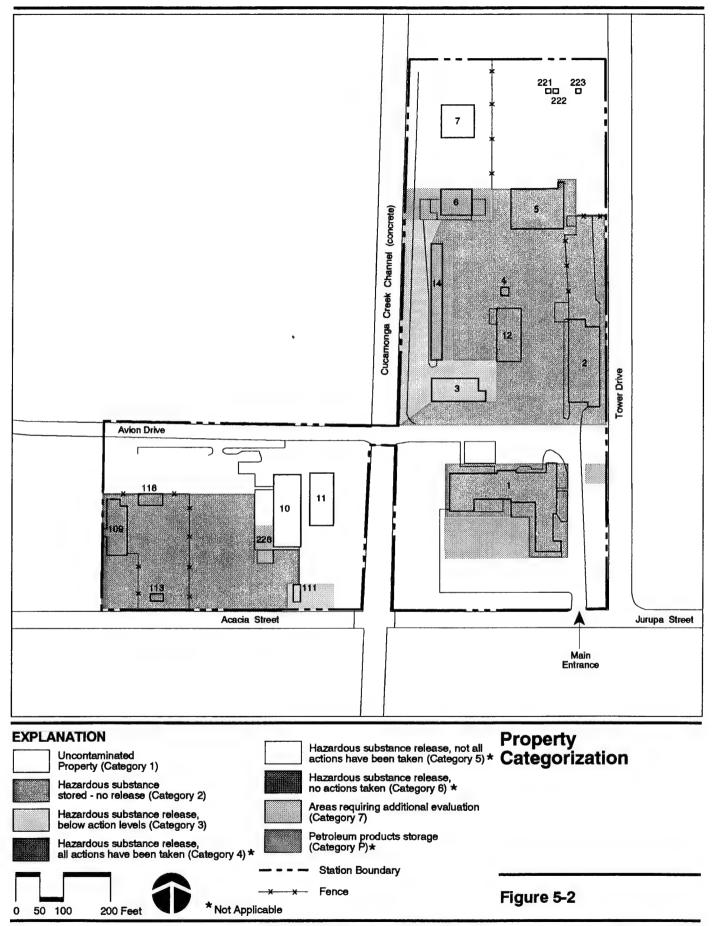
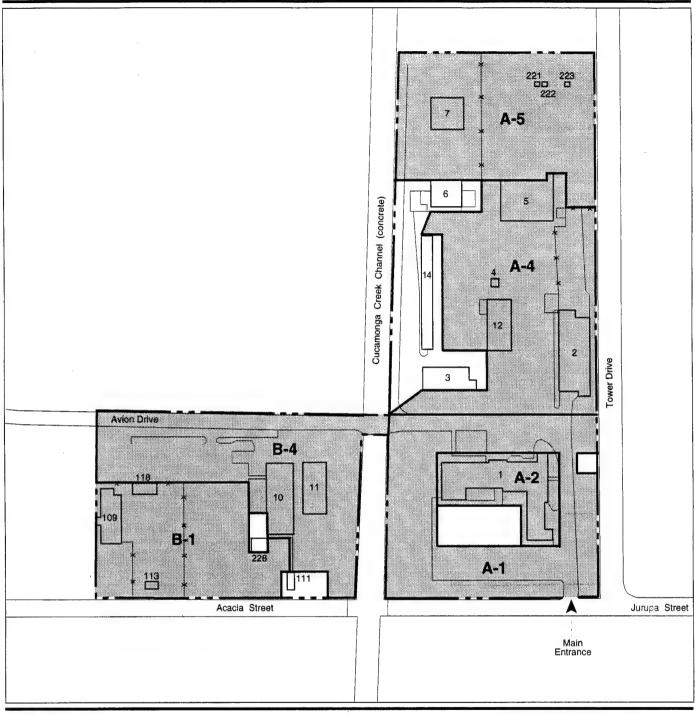
Figure 5-1

## Location of Environmental Factors
